## Coil Wound Products

This Workmanship Standard details the workmanship acceptance criteria to be applied to L3Harris Communication Systems-West (CSW), Salt Lake City facility products.

### WORKMANSHIP STANDARD

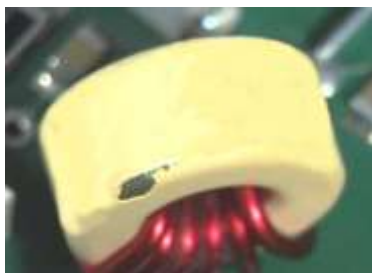
**Acceptable**

- A. Chips, nicks, or scratches in the paint/coating are allowed providing the core (ferrite material) is not damaged.
- Windings are concentrated in one general area with the specified number of turns per drawing.

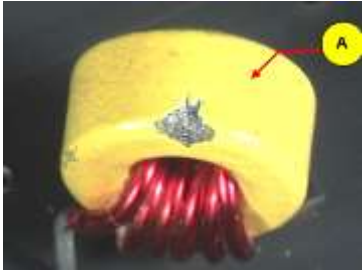
**Nonconforming**

- A. Chips or nicks have gone beyond the paint/coating surface and have damaged the core (ferrite material).

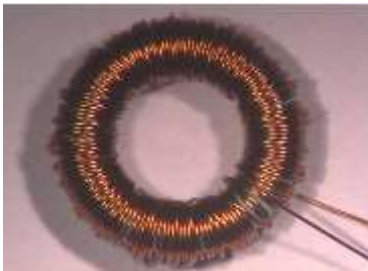
**Acceptable**

- Number of turns are as specified per drawing. Inherent overlap is uniformly distributed.
- The windings are free of nicks or deformation.
- The windings are free of kinks.
- The windings are free of exposed base metal.

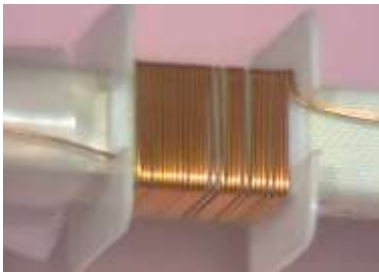
**Target Condition**

- The wire is free of kinks or deformations with no base metal exposed.

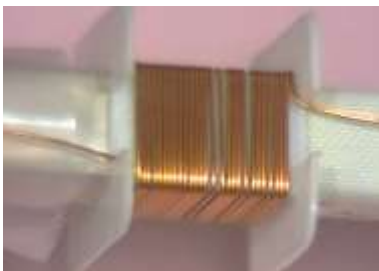
**Acceptable**

- Single layer winding, with the windings tight against the bobbin.
- Number of turns are as specified per drawing.

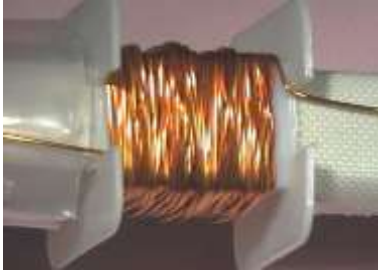
**Acceptable**

- When specified per drawing, windings are wound in a crisscross pattern.

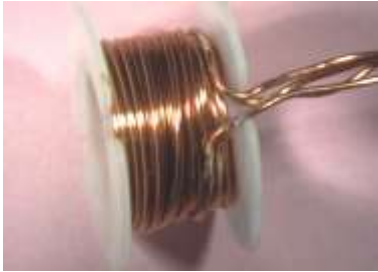
**Nonconforming**

- **(Bifilar)** Double wire strands wound tight against the bobbin with the specified number of turns per drawing.

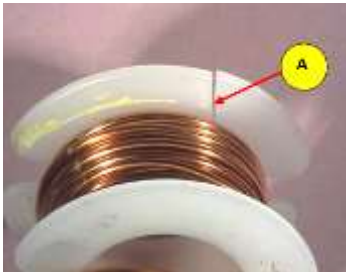
**Nonconforming**

- A. Bobbin is cracked or broken.

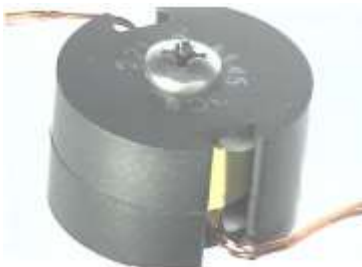
**Target Condition**

- Coil housing is aligned top to bottom.
- Wiring exit slots are aligned.

Note: hardware is shown for build purposes only, prior to bonding.

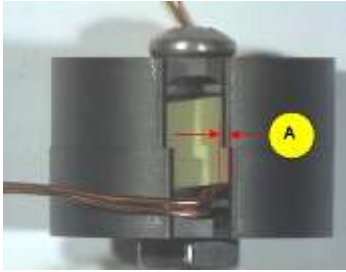
**Acceptable**

- Misalignment of wiring slots shall not exceed .03 inch.

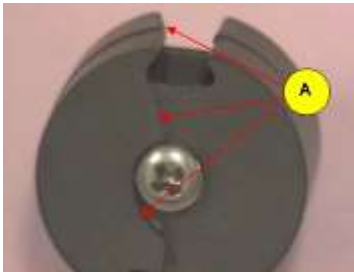
**Nonconforming**

- A. Cracks or chips in the composite material of the coil housing.

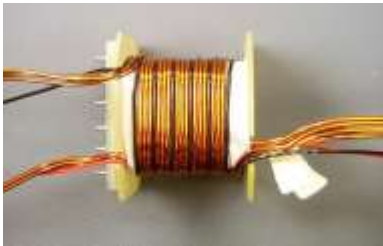
**Acceptable**

- Trifilar winding is tight against the core or previous winding.
- Number of turns are as specified per drawing.
- Entry and exit of wires are in the correct slot per drawing.
- The windings are free of nicks or deformation.
- The windings are free of kinks.
- The windings are free of exposed base metal.

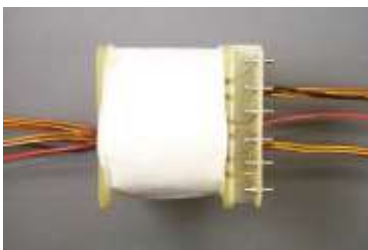
**Acceptable**

- Number of layers of paper/tape covering windings are as specified per drawing.

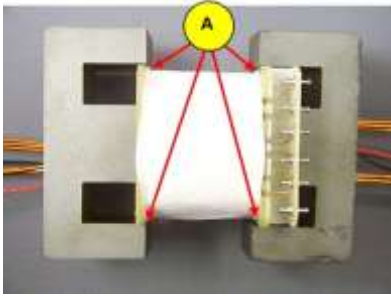
**Acceptable**

- A. Windings and paper/tape do not interfere with the installation of the E-Cores.

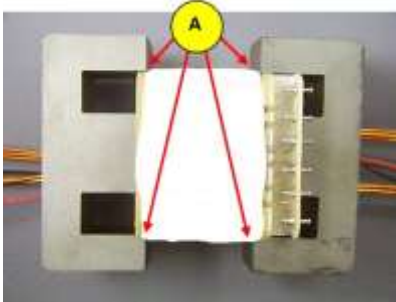
**Nonconforming**

- A. Wiring and/or paper/tape windings are causing interference with the installation of the E-Cores.

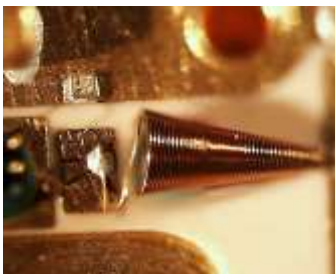
**Target Condition**

**Note:** Magnification 27X

- Wire remains continuous to connection point.
- Wire does not span the gap between pads more than 50 percent.
- Wire insulation is not evident in epoxy connection

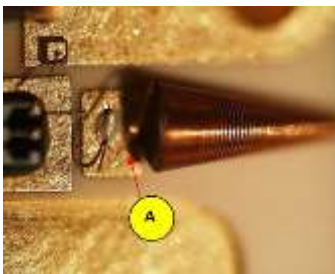
**Acceptable**

- A. Wire is only slightly unwound to connection point.
- Wire does not span the gap between pads more than 50 percent.
- Wire insulation is not evident in epoxy connection.

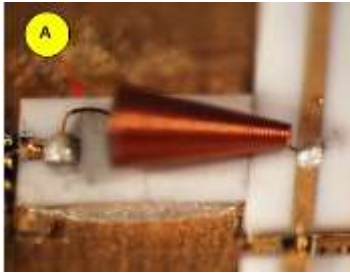
**Acceptable**

- A. Wire remains continuous to connection point.
- Wire does not span the gap between pads more than 50 percent.
- Wire insulation is not evident in epoxy connection.

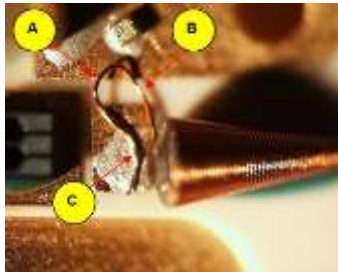
**Nonconforming**

- A. Wire is not continuous to connection point.
- B. Wire spans the gap between pads more than 50 percent.
- C. Wire insulation is evident in epoxy connection.
